NASA CR-72733

FINAL REPORT  
CRYOGENIC ALLOY SCREENING

By F. R. Schwartzberg, R. D. Keys,  
and T. F. Kiefer

Prepared under Contract No. NAS3-11203 by  
MARTIN MARIETTA CORPORATION  
Denver, Colorado  
for

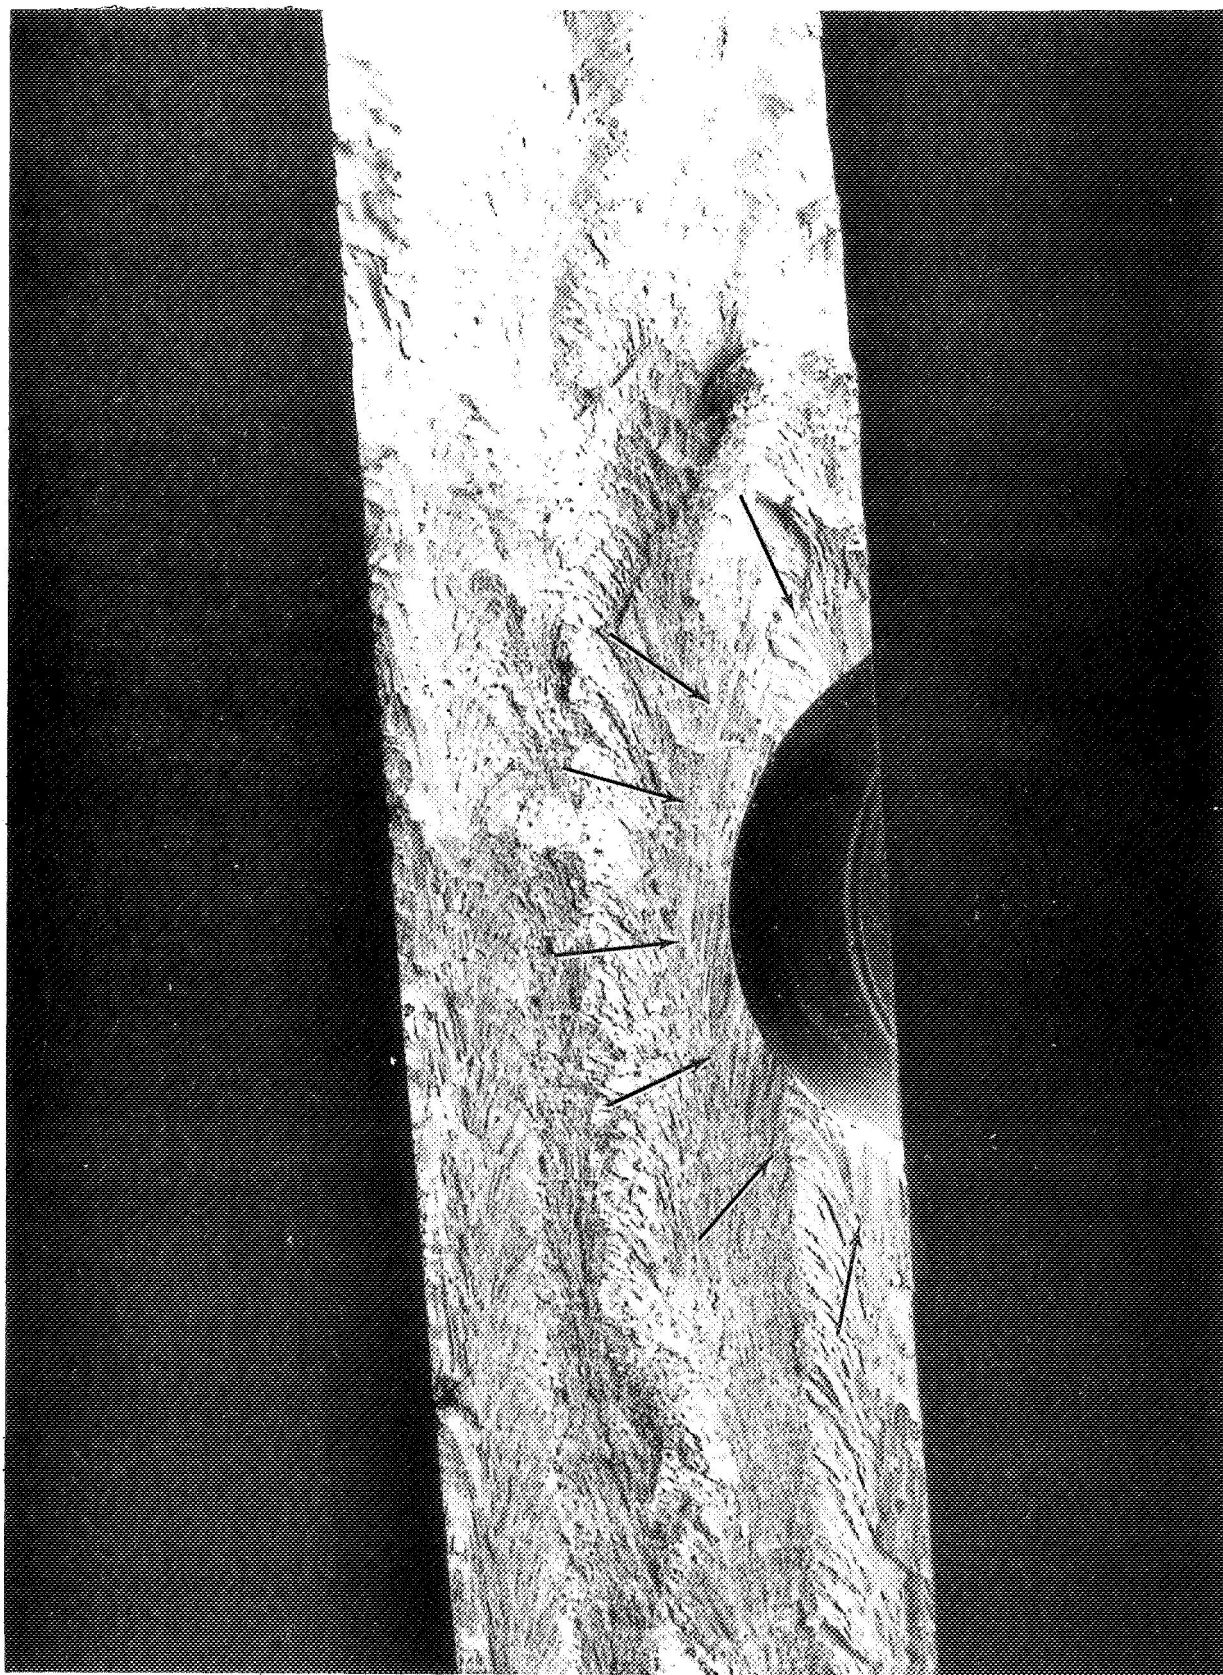
Fig. VI-11 Fracture Face of Welded X7007-T6 Surface-Flawed Specimen  
(Arrows Indicate Extent of Fatigue Advanced Flow)

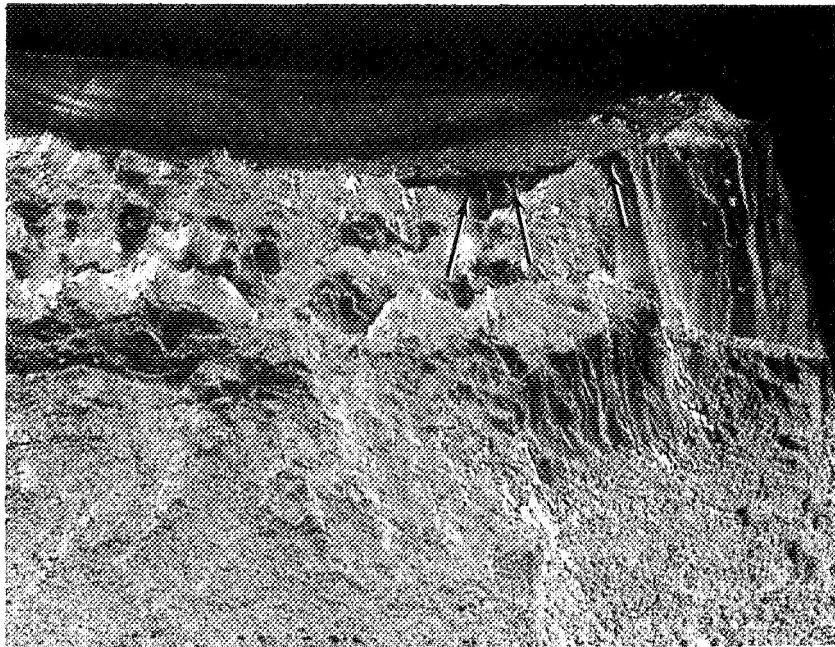
Fig. VI-12 Fracture Face of Al X7007-T6 Surface-Flawed Specimen Showing Staining along Delaminated Crack Front
